**IN THE UNITED STATES DISTRICT COURT  
FOR THE DISTRICT OF PUERTO RICO**

**FIRST AMENDED COMPLAINT**

States Coast Guard's agents and employees negligence that resulted in a collision between the CGC WINSLOW GRIESSER, a Sentinel Class 154-foot Fast Response Cutter, with the DESAKATA, a 23 foot in-length center console vessel, on August 8, 2022, approximately four (4) nautical miles north of Dorado, Puerto Rico.

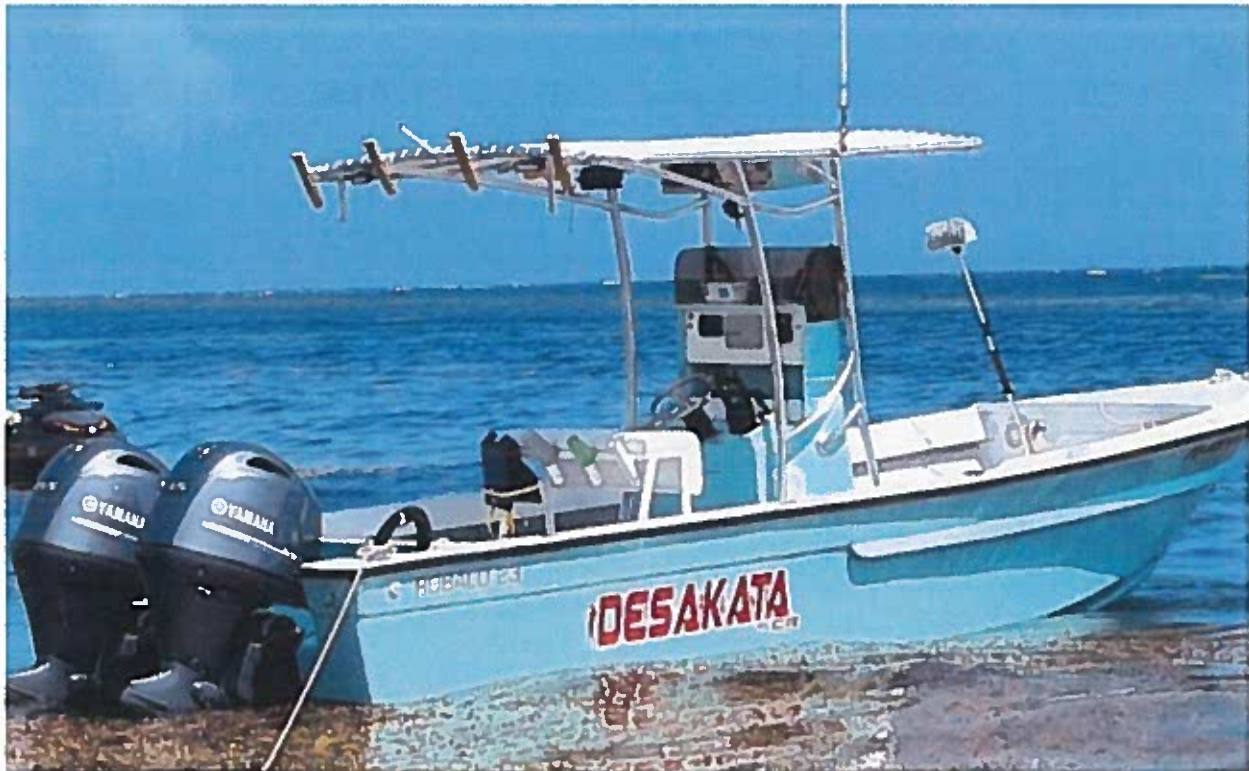
Figure 1 Center-console boat *Desakata* before the collision. Source: NTSB Report 7-03-2023. See <https://www.nts.gov/investigations/AccidentReports/Reports/MIR2314.pdf>

the Operator of the *Desakata*, a 1977 23 foot in-length Robalo Center Console (See Figure 1), along with crew member and brother, Carlos Lico Rosario Beltrán, while transiting northbound, trolling and doing commercial fishing at approximately four (4) nautical miles north of Dorado, Puerto Rico. Samuel Rosario Beltrán was the owner of the boat.

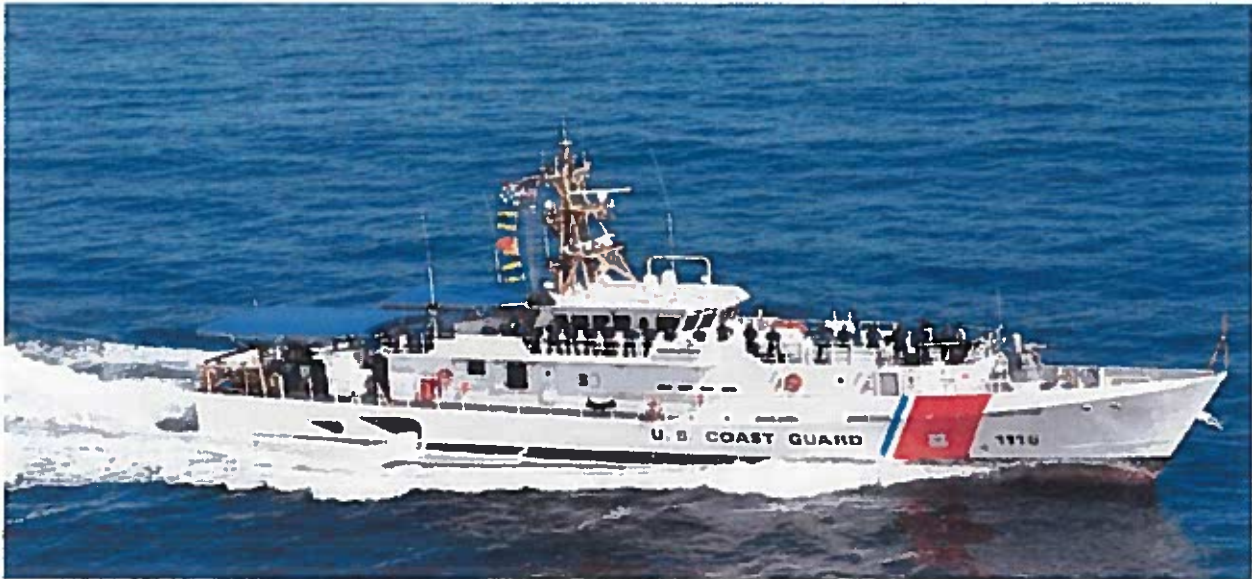
Figure 2. US Coast Guard cutter *Winslow Griesser*. Id.

5.3 The CGC *Winslow Griesser*, a Sentinel Class **154-foot** Fast Response Cutter (See Figure 2), was identified to support an operation whereby two Dominican Republic Navy Shipriders would embark on a U.S. Coast Guard asset on August 8, 2022 at 1600 in Punta Cana, Dominican Republic. The transit distance from San Juan,

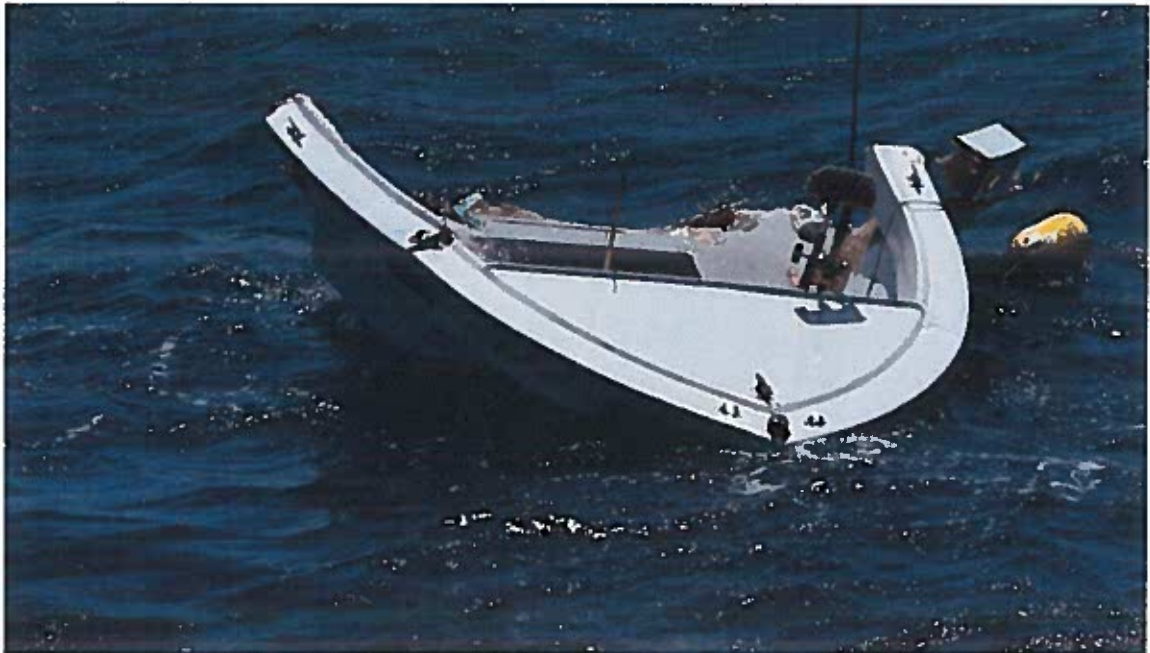
Figure 4. The Desakata's bow section adrift immediately after the collision. Id.

5.8 At approximately 1417 on said day the CGC *Winslow Griesser* collided with the *Desakata* (See Figure 3 above), approximately four nautical miles north of Dorado, Puerto Rico. As a direct result of said collision Mr. Carlos Lico Rosario Beltrán was fatally injured and Mr. Samuel Rosario Beltrán was seriously injured. The *Desakata*, valued at \$58,800.00, was a total loss. (See Figure 4).

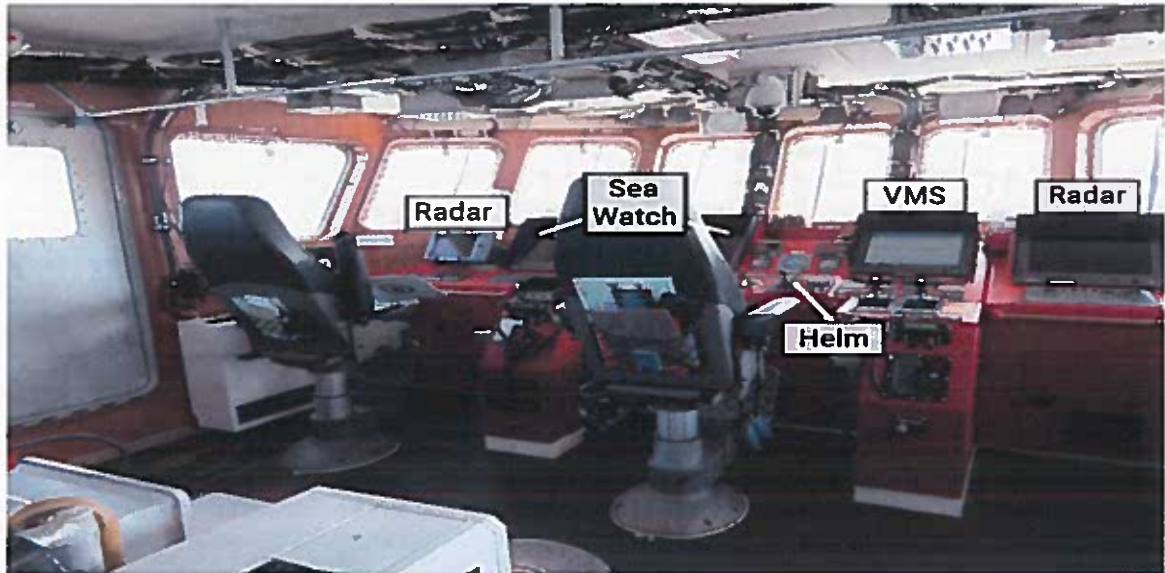
Figure 4. *Winslow Griesser* bridge, looking forward and to port. Id.

5.11 The *Winslow Griesser* was outfitted with two radars, a Vega electronic chart display and information system (ECDIS), and a Global Maritime Distress and Safety System (GMDSS) console, among other Coast Guard-specific equipment. On the bridge forward console, from port to starboard, was a Furuno DRS4A radar display and a SeaWatch station in front of the captain's chair; another SeaWatch station and

the helm station in front of the helmsman's chair; a vessel management system (VMS) console; and a Furuno AN/SPS-50 radar (See Figures 4 and 5).
